ROCKAWAY BEACH, MO PHOTO LOG

9/13/2007

ROCKAWAY BEACH WWTF
Rockaway Beach, MO.

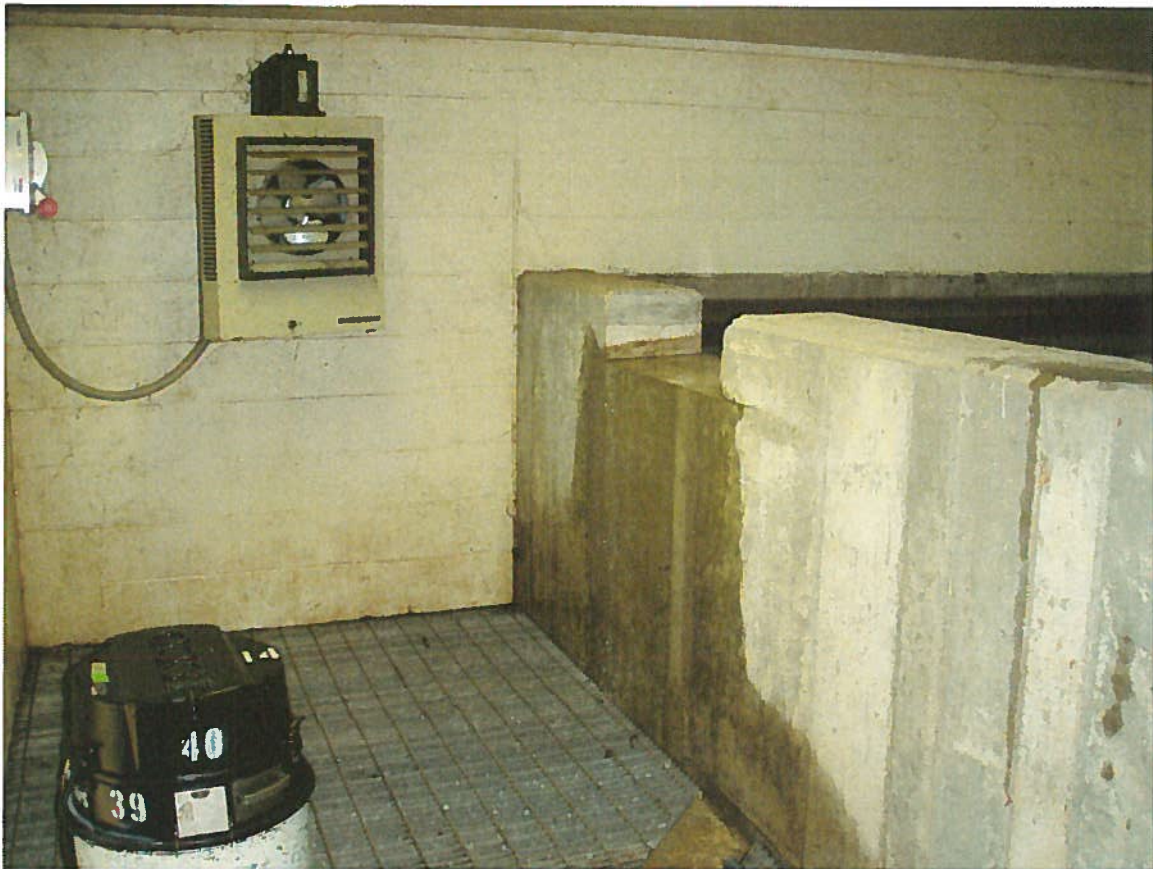
Photo no. 1 This photo was taken inside the sand filter building. The water flowing through the wall opening didn't go through the filter into the ultraviolet light disinfection channel. This is a bypass.

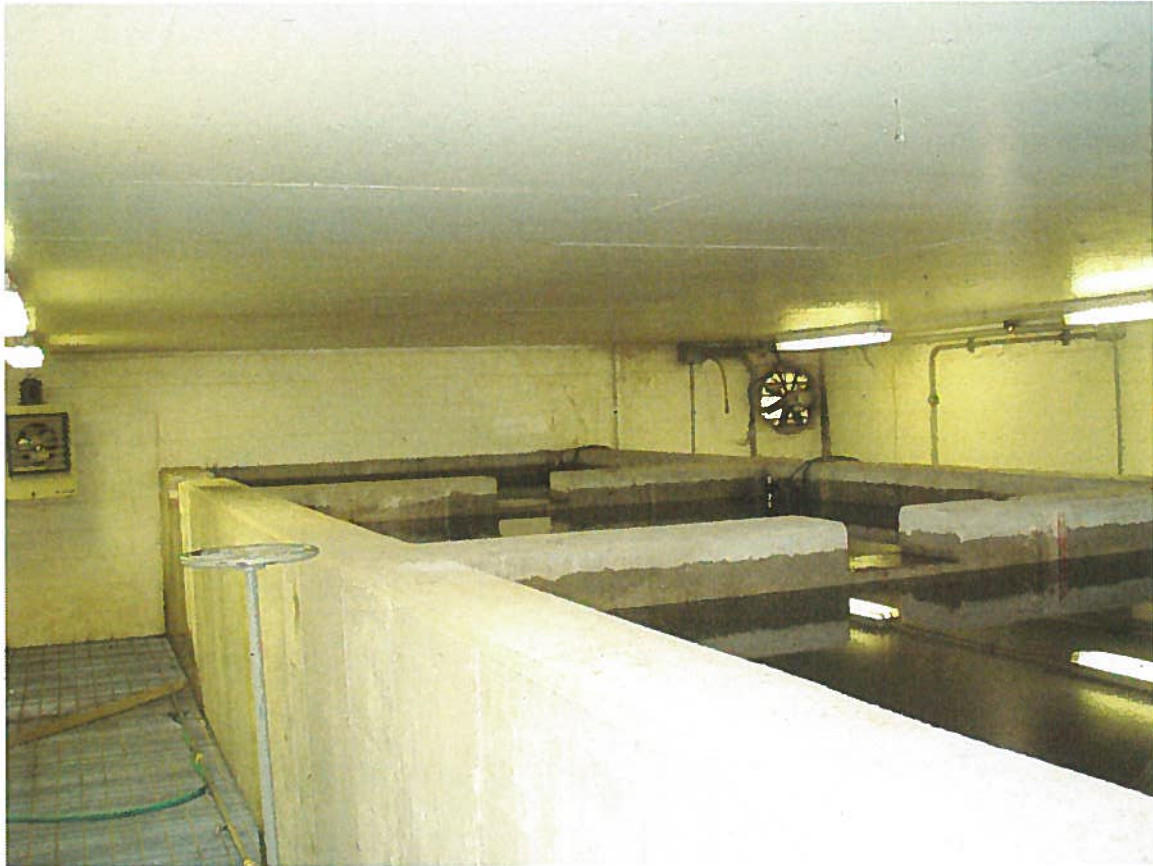
Photo no. 2 This photo was taken inside the sand filter building. Visible are three of the four sand filter basins used to remove solids before the ultraviolet light disinfection channel. The sand filters are not in use in this photo.

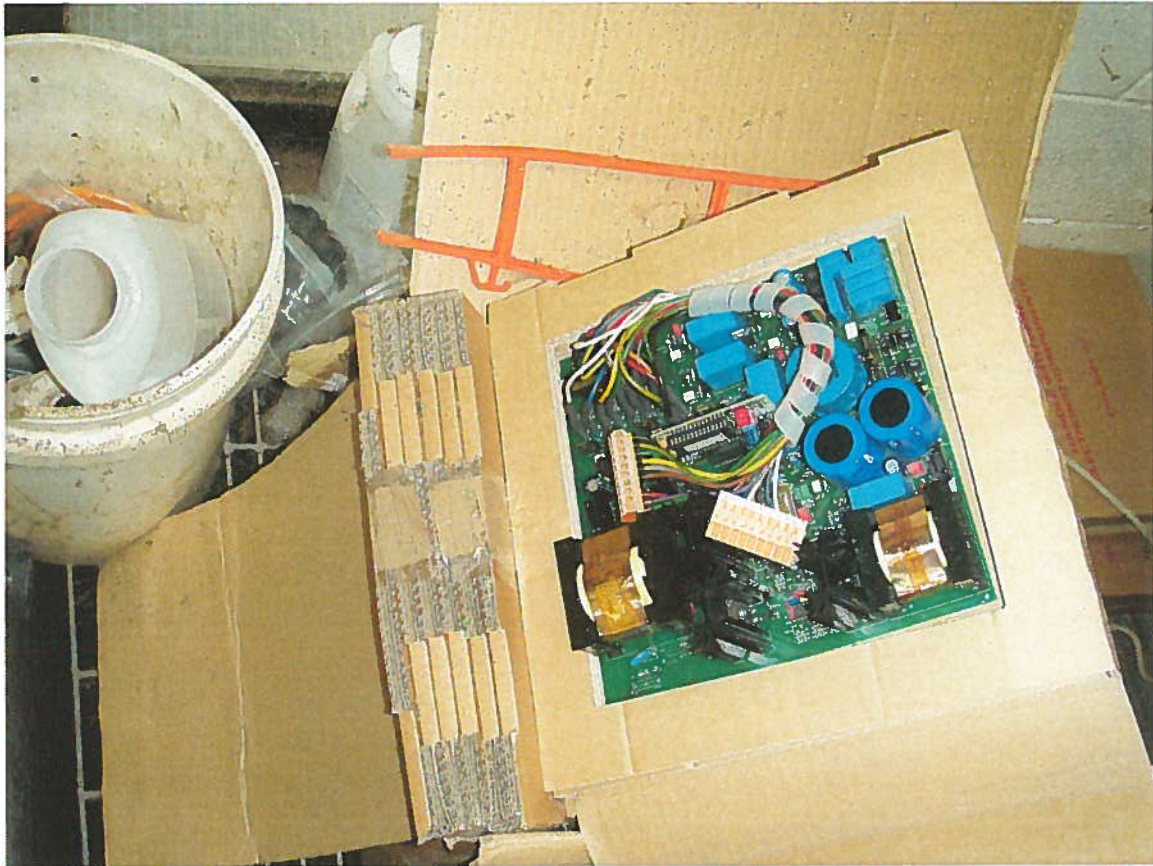
Photo no. 3 This photo was taken inside the sand filter building. These circuit boards were said to be the discards when new circuit boards were installed in the ultraviolet light system. According to the facility operator, the circuit boards are not repairable.

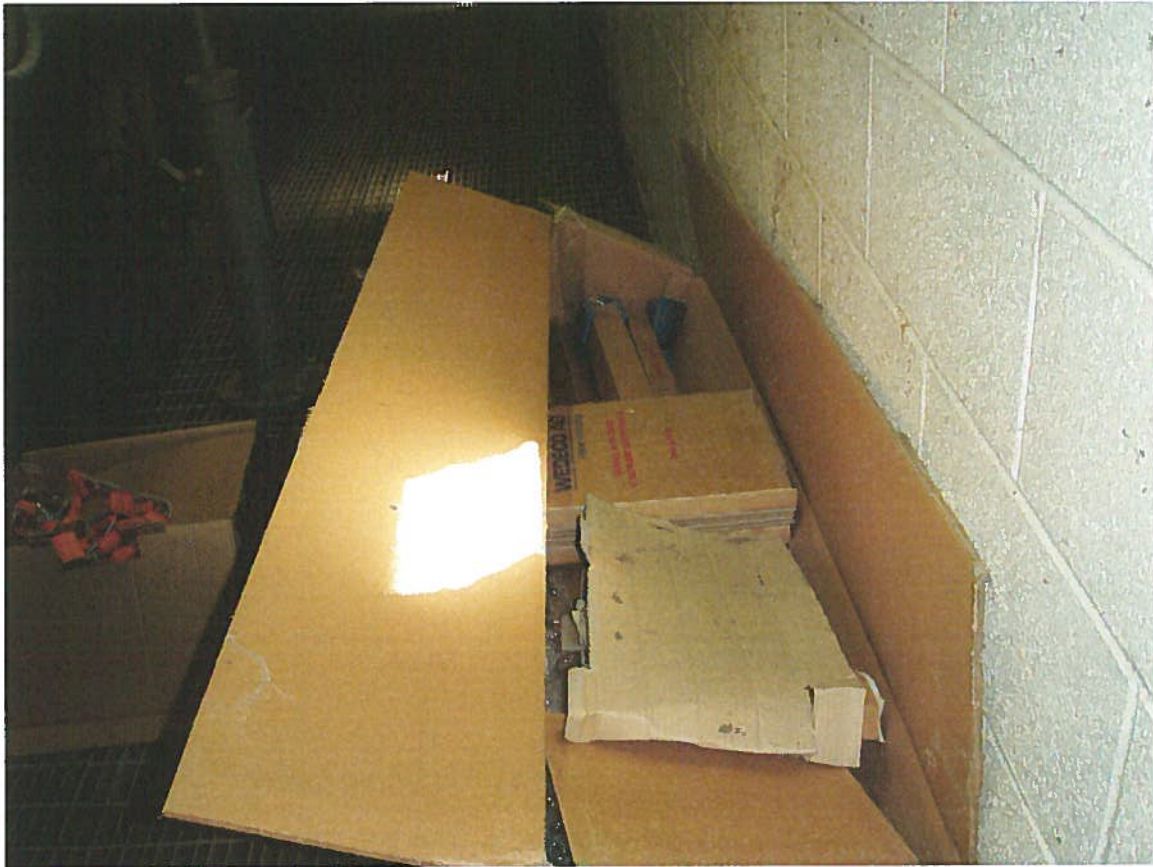
Photo no. 6 This photo was taken inside the sand filter building. This box contained ultraviolet light bulbs that, according to the plant operator, had been replaced by new ones. It would seem appropriate to dispose of the bulbs or to mark the box with the contents and their operational status.

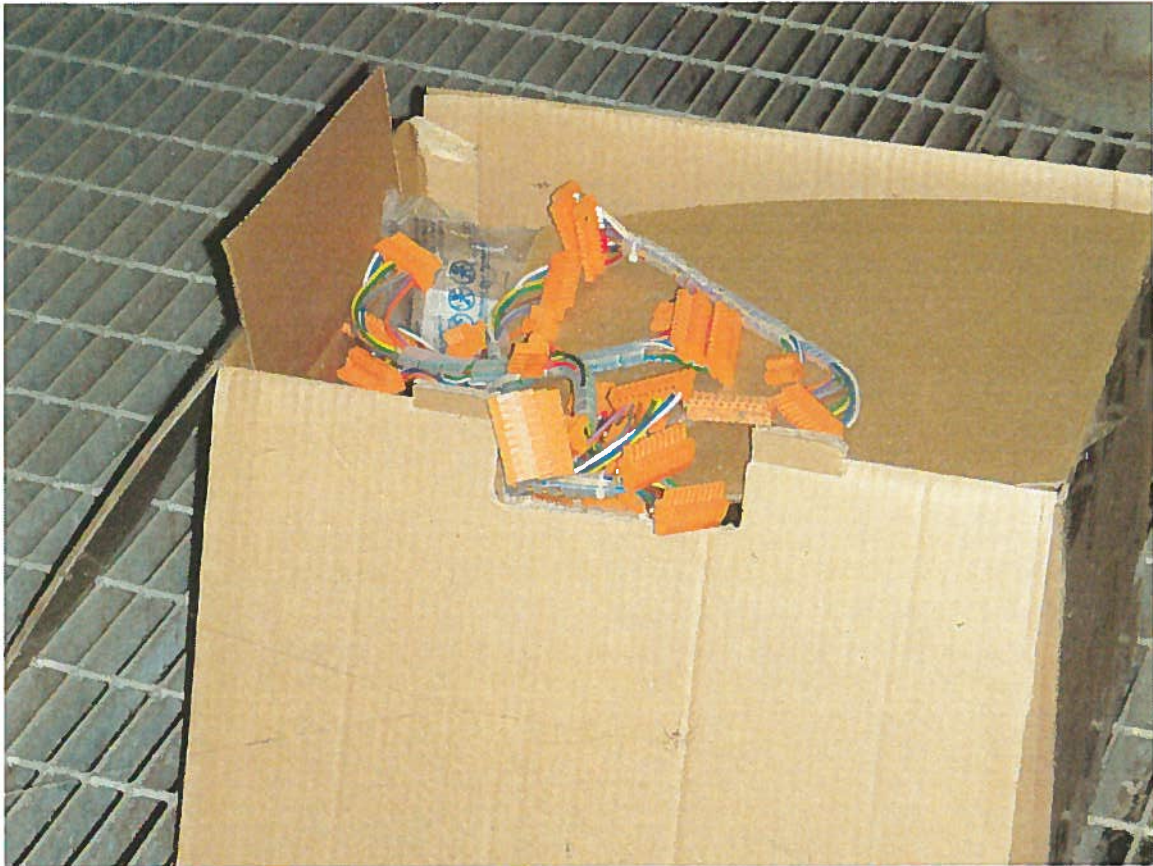
Photo no. 7 This photo was taken inside the sand filter building. This box contained ultraviolet light connectors that were remaining after the light and circuit boards were replaced.

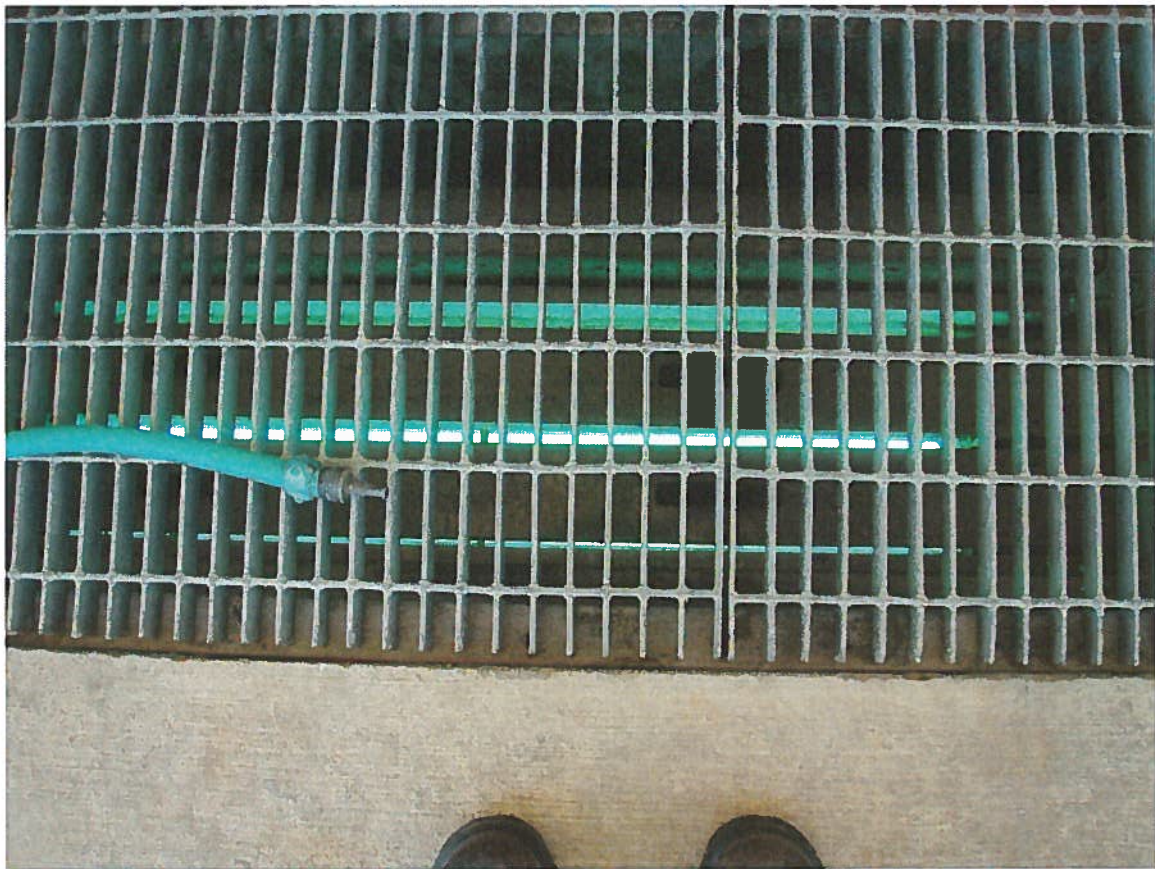
Photo no. 9 This photo was taken on the east outside the sand filter building. This photo was taken looking down at the ultraviolet light banks. The lights are submerged in water. The number of bulbs lit cannot be determined by eye.

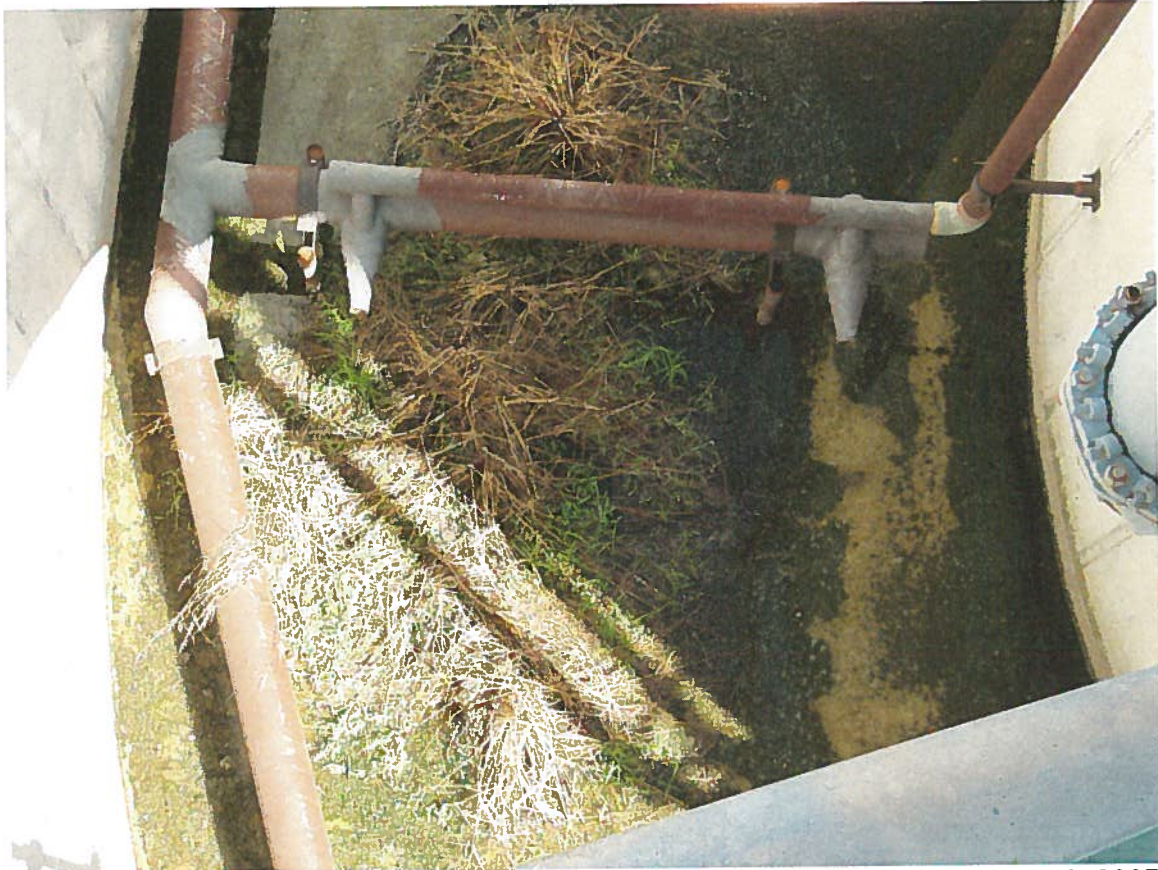
Photo no. 11 This photo was taken looking into the southeast aeration tank. The piping to the left side is connected to the motive pump which recirculates the tank liquid. The pipe at the right is an air line which feeds air into the liquid as the liquid is expelled from the nozzles. A similar arrangement is located at quarter points in the tank. This tank has not been used for about three years which has allowed vegetation to grow in the bottom supported by sludge left behind when the tank was drained.

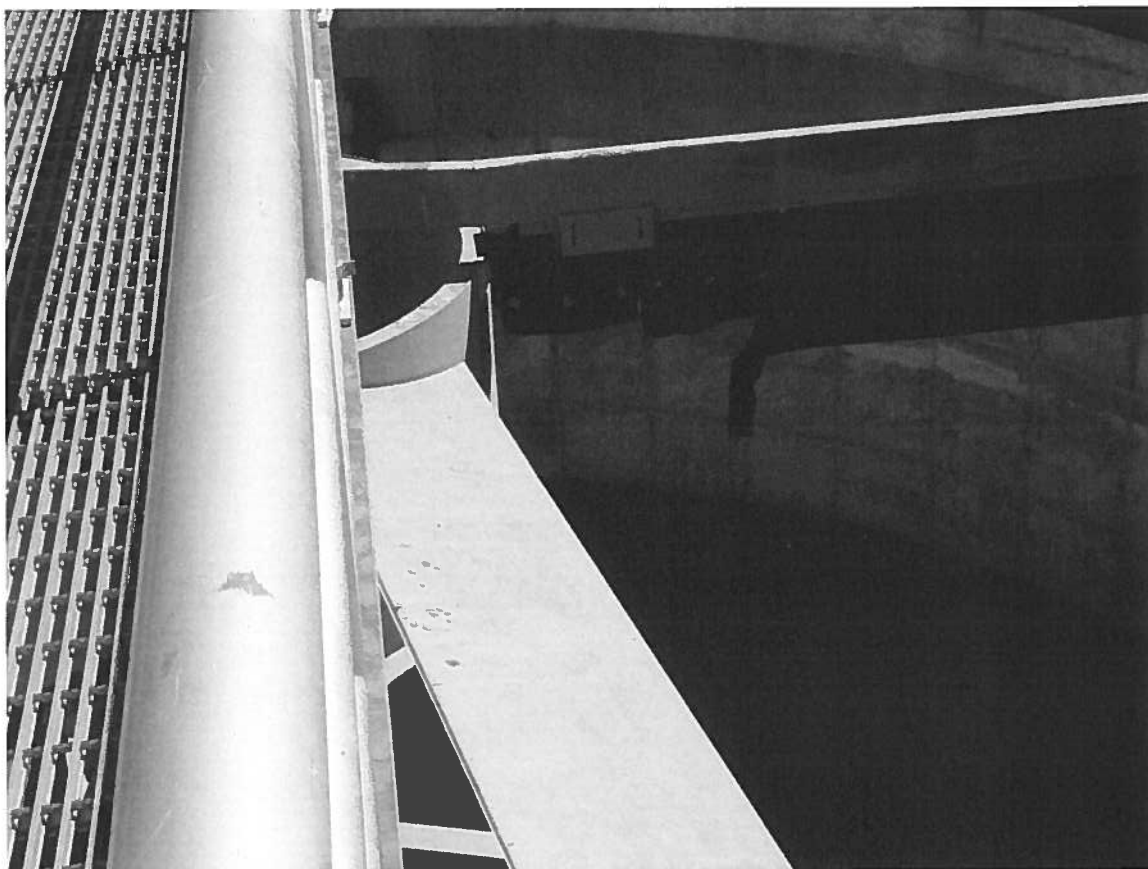
Photo no. 12 This photo was taken looking at the clarifier surface skimmer of the new clarifier not in use.

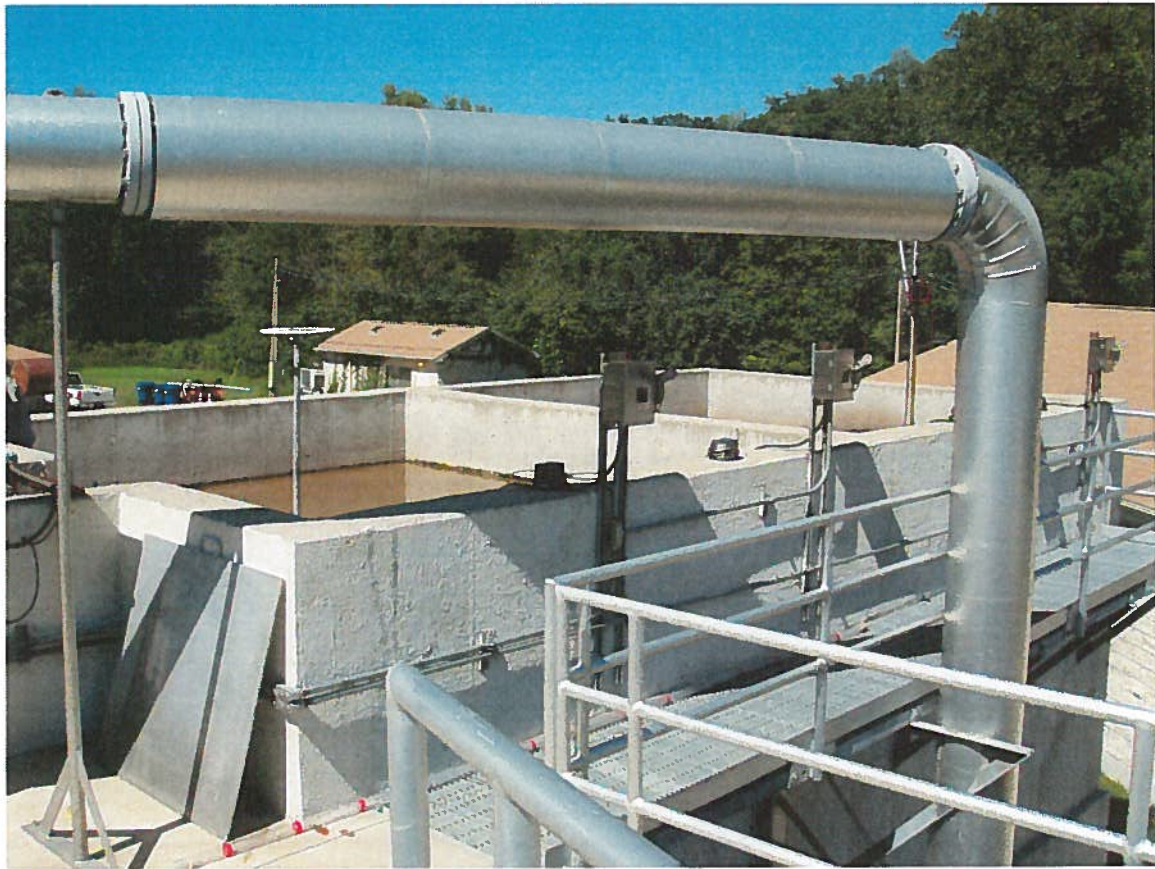
Photo no. 13 This photo was taken looking northwest from the influent headworks located between the two aeration tanks. The photo shows the anoxic basins. The building in the upper left of the photo is the laboratory/office. The silver pipe at the top of the photo carries material from the mechanical bar screen to a container on the ground.

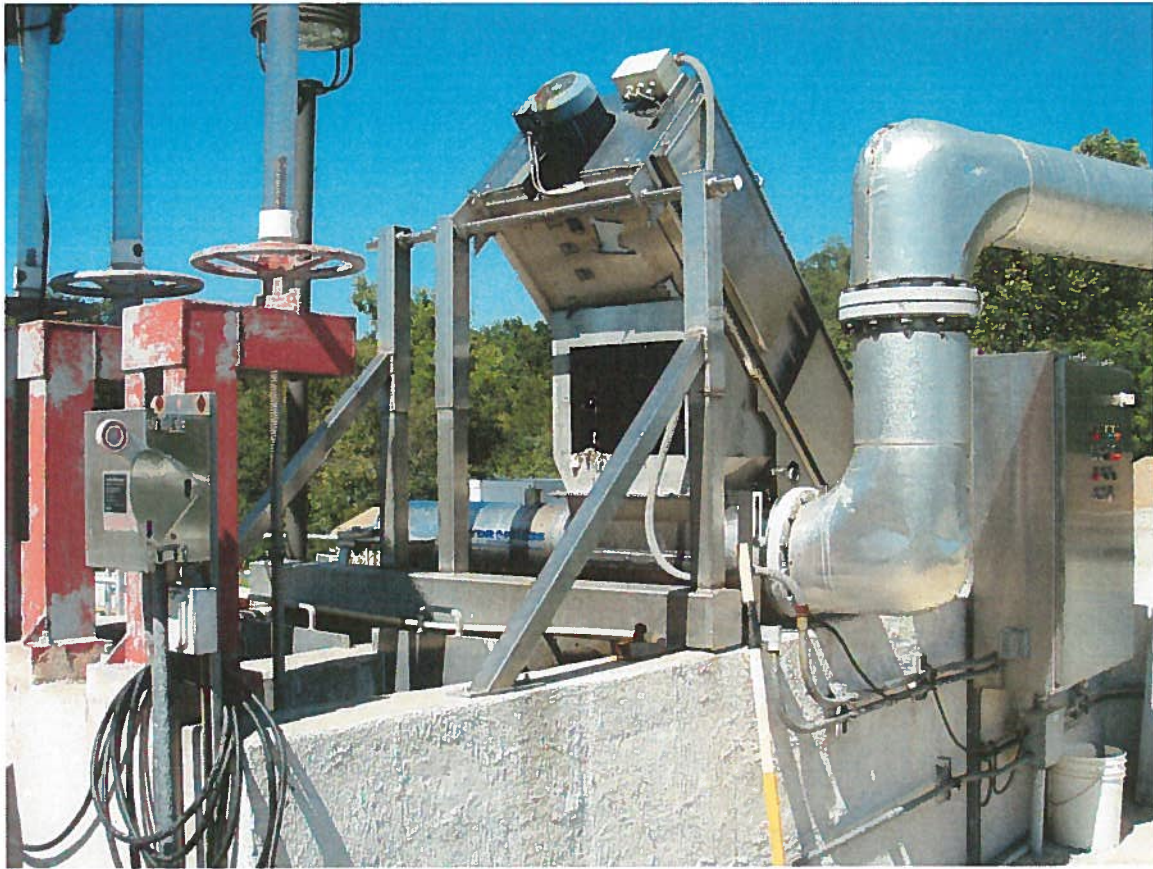
Photo no. 14 This photo was taken looking northwest from the influent headworks located between the two aeration tanks. The photo shows the upper end of the mechanical bar screen. The pipe to carry the screenings to a container on the ground is located at the right of the unit.

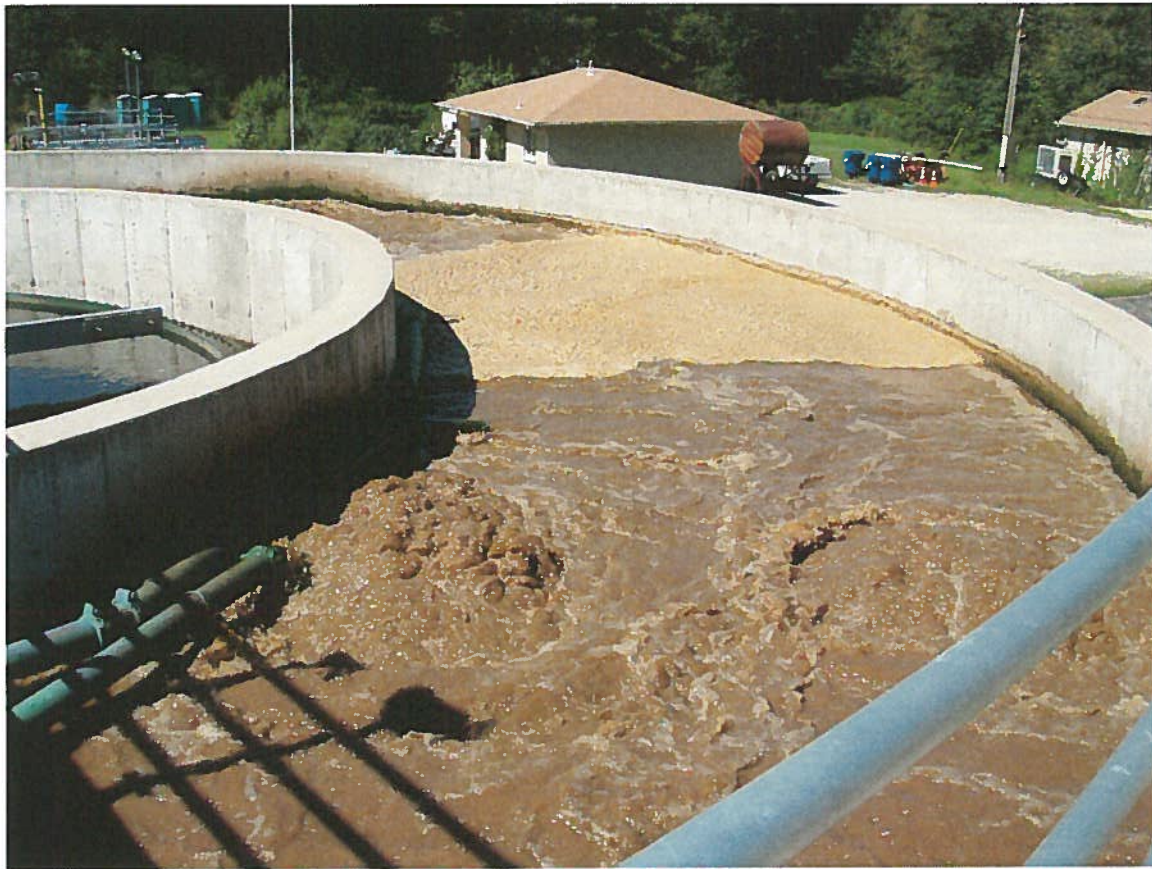
Photo no. 15 This photo was taken looking northwest from the headworks structure looking at the west aeration basin. Note the large boil type aeration pattern. A fine bubble pattern would add more air. The building at the upper center is the laboratory/office. Located at the right edge of the photo is the raw sewage pump building.

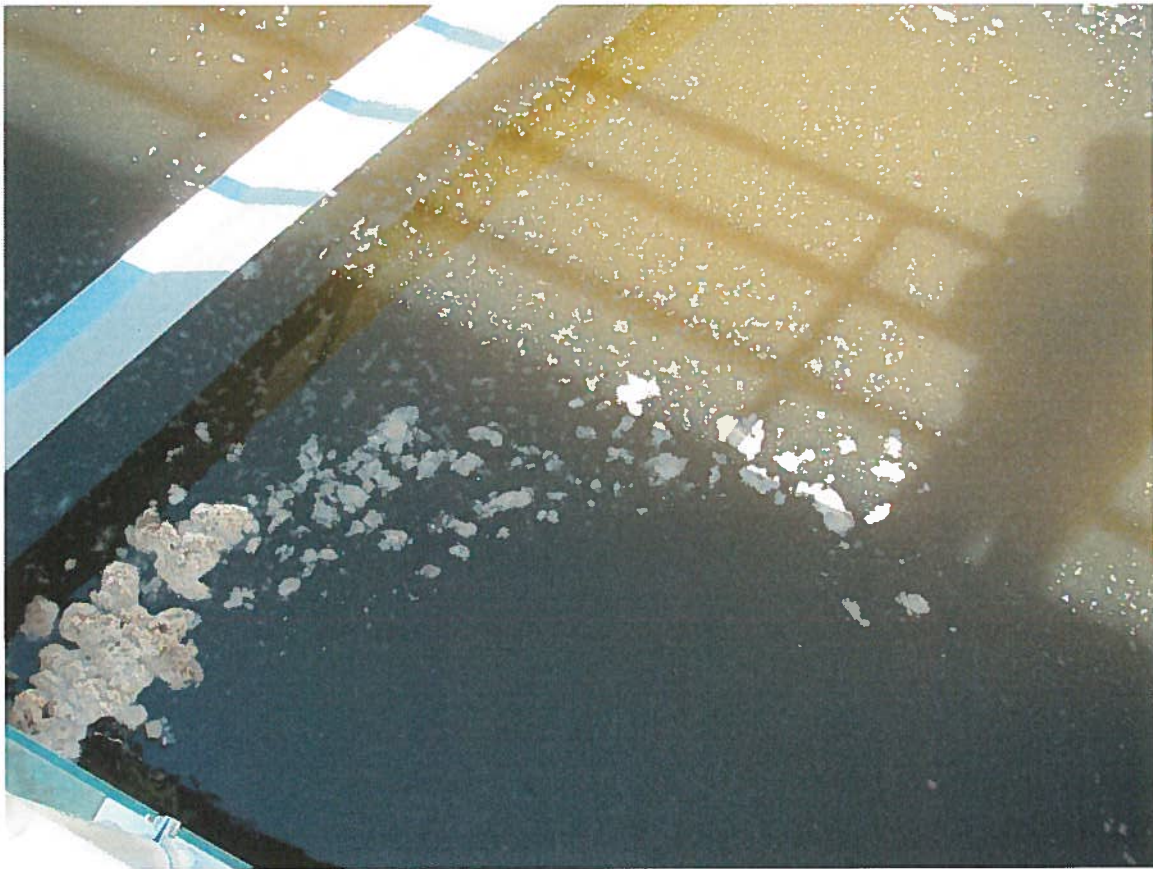
Photo no. 16 This photo was taken looking down at the surface of the final clarifier. Floating surface scum is visible.

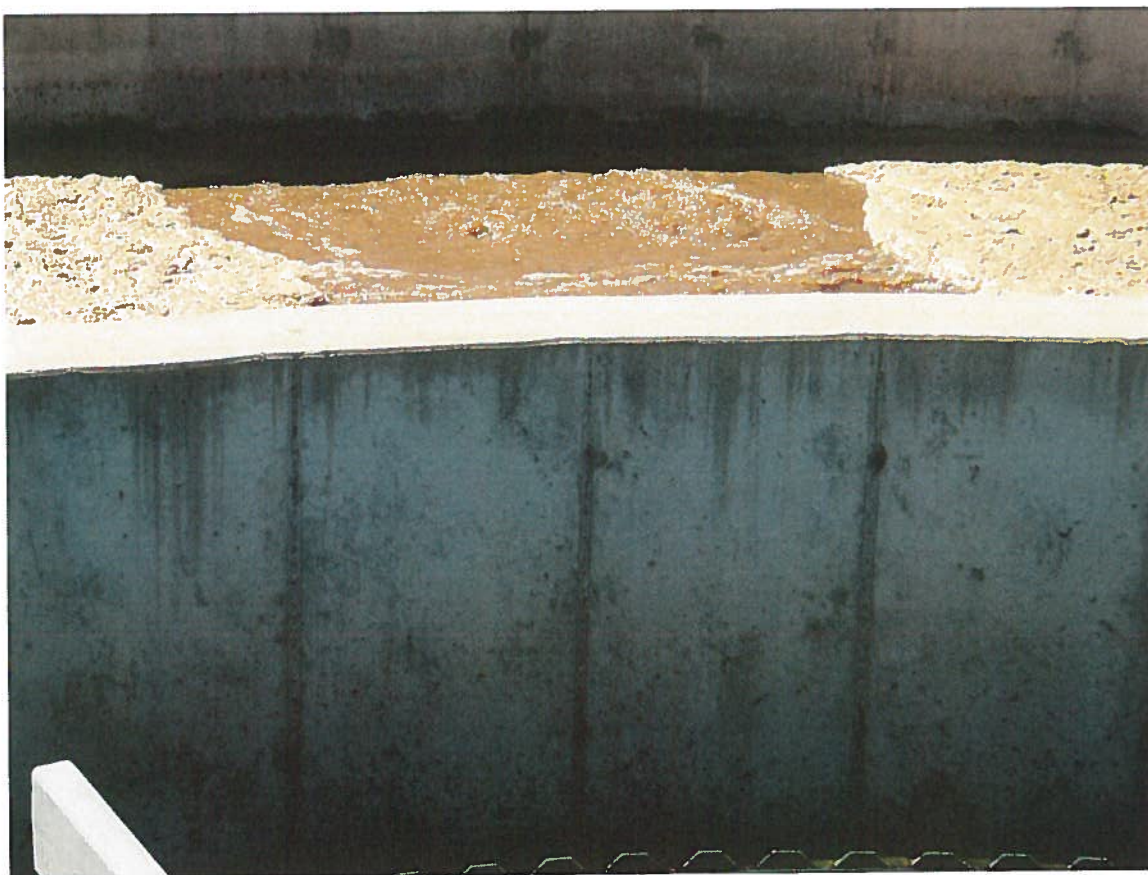
Photo no. 17 This photo was taken looking west at the west aeration basin. The photo was taken from the final clarifier bridge. The aeration bubble was large indicating coarse bubble diffusion resulting in poor oxygen transfer.

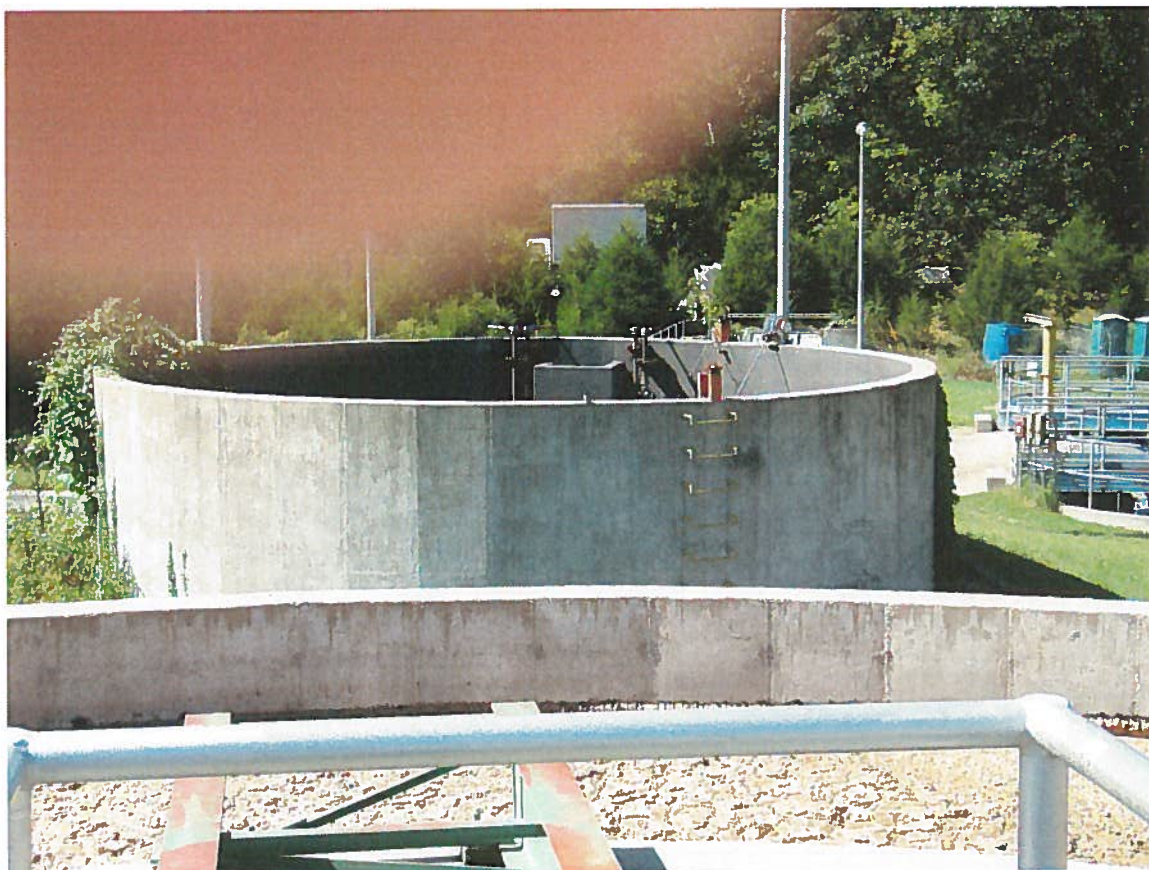
Photo no. 18 This photo was taken looking northwest from the west final clarifier access bridge. The upper center of the photo shows the sludge storage tank. This tank has not been used since the new plant was constructed.

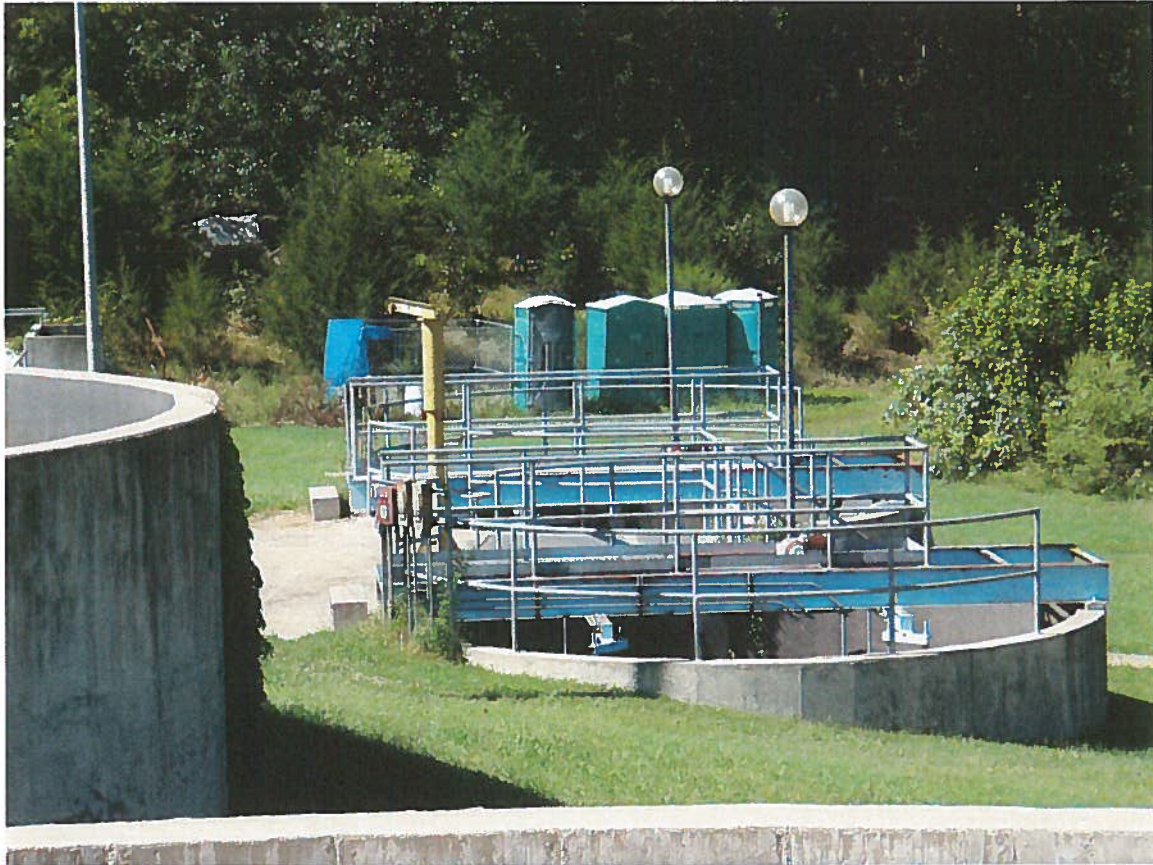
Photo no. 19 This photo was taken looking northwest from the west final clarifier access bridge. The photo shows the sludge storage tank at the left of the photo. The two final clarifier tanks associated with the old plant are shown at the center right. The plant design intent was to use these clarifiers as gravity thickeners then store the sludge in the sludge storage tank. These tanks are currently used as storage with no regard to sludge thickening.

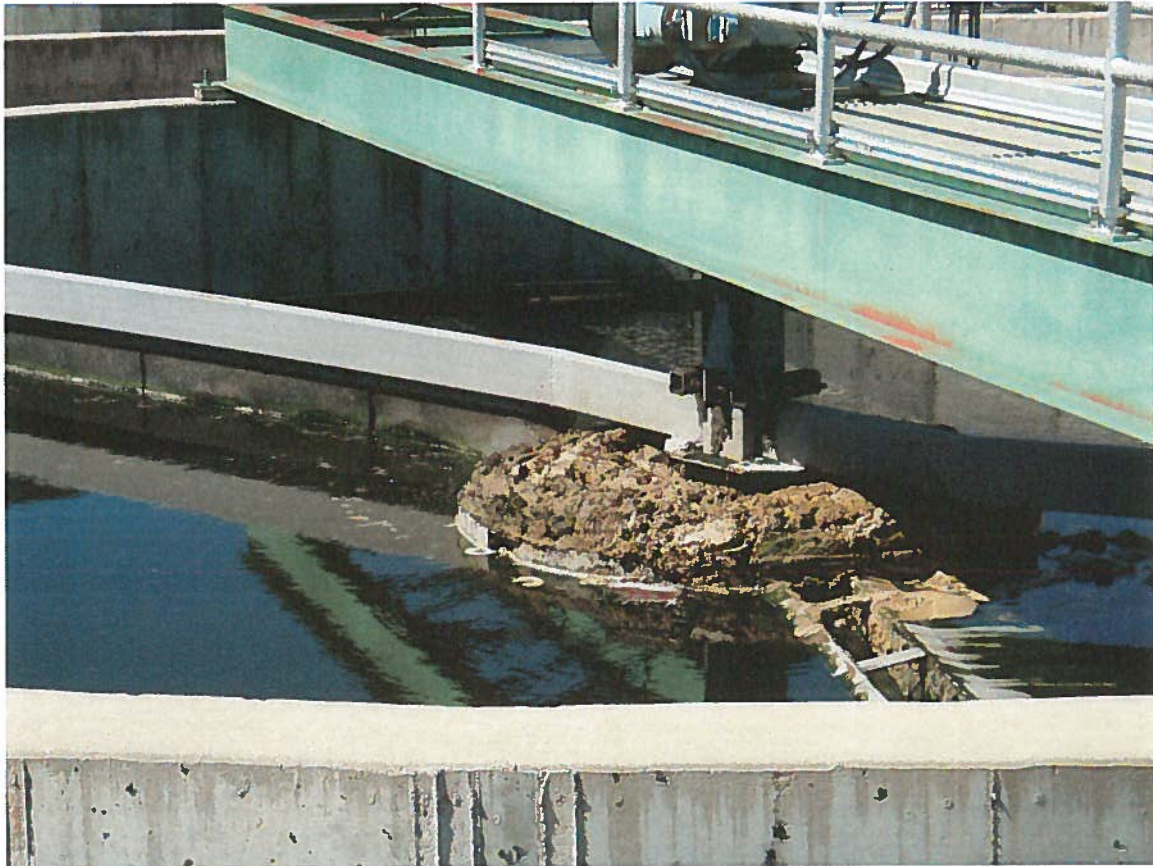
Photo no. 20 This photo was taken looking northwest from near the old final clarifier. Some water could be decanted from the clarifier surface.

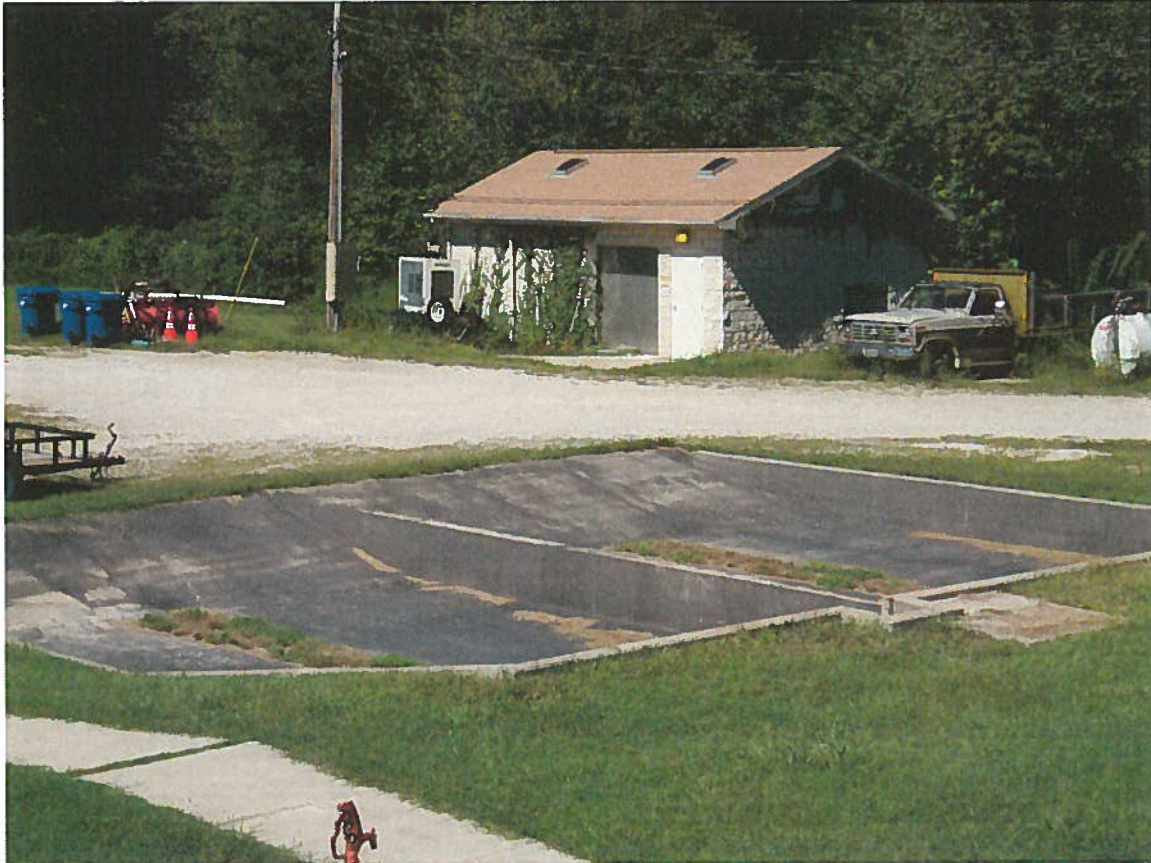
Photo no. 21 This photo was taken looking north from near the sand filter building. Located in the foreground are two paved drying beds. Bed drainage would be through the grassy strip in the middle of the bed. The raw sewage pumping building is located in the background. The portable generator shown at the left corner of the pump building is not hooked to anything and is not ready to be used.
